2005-08 ACCESSORIES AND EQUIPMENT

Seat Heaters - RL

2007 Acura RL

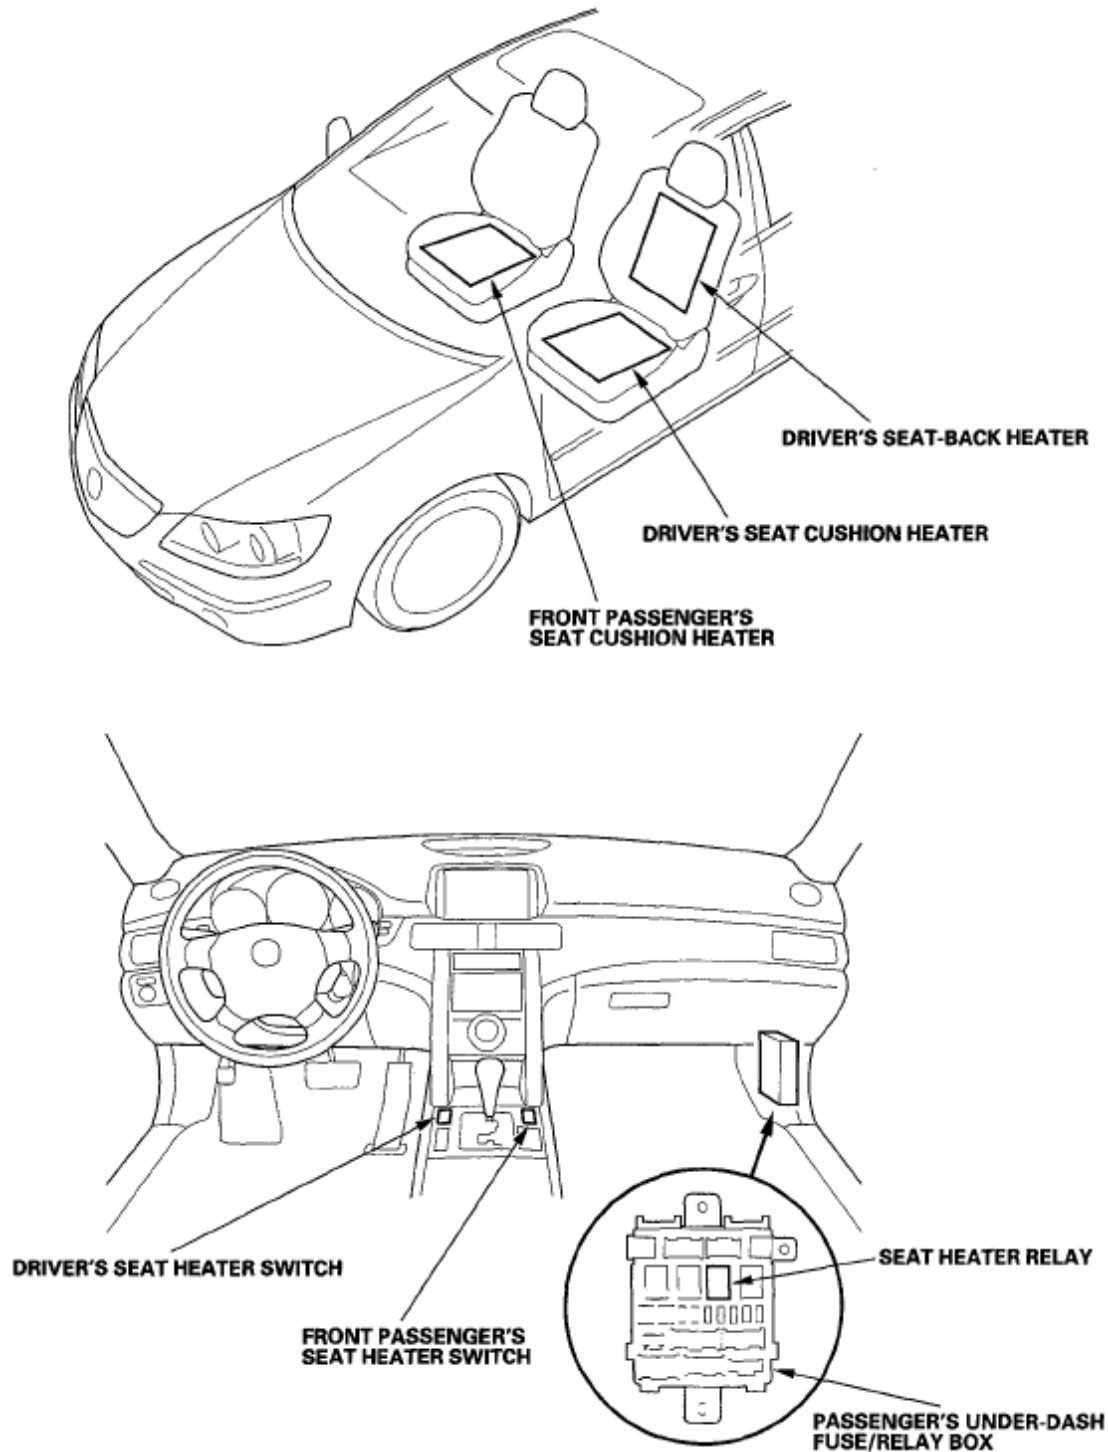
Fig. 1: Identifying Seat Heaters Component Location
Courtesy of AMERICAN HONDA MOTOR CO., INC.

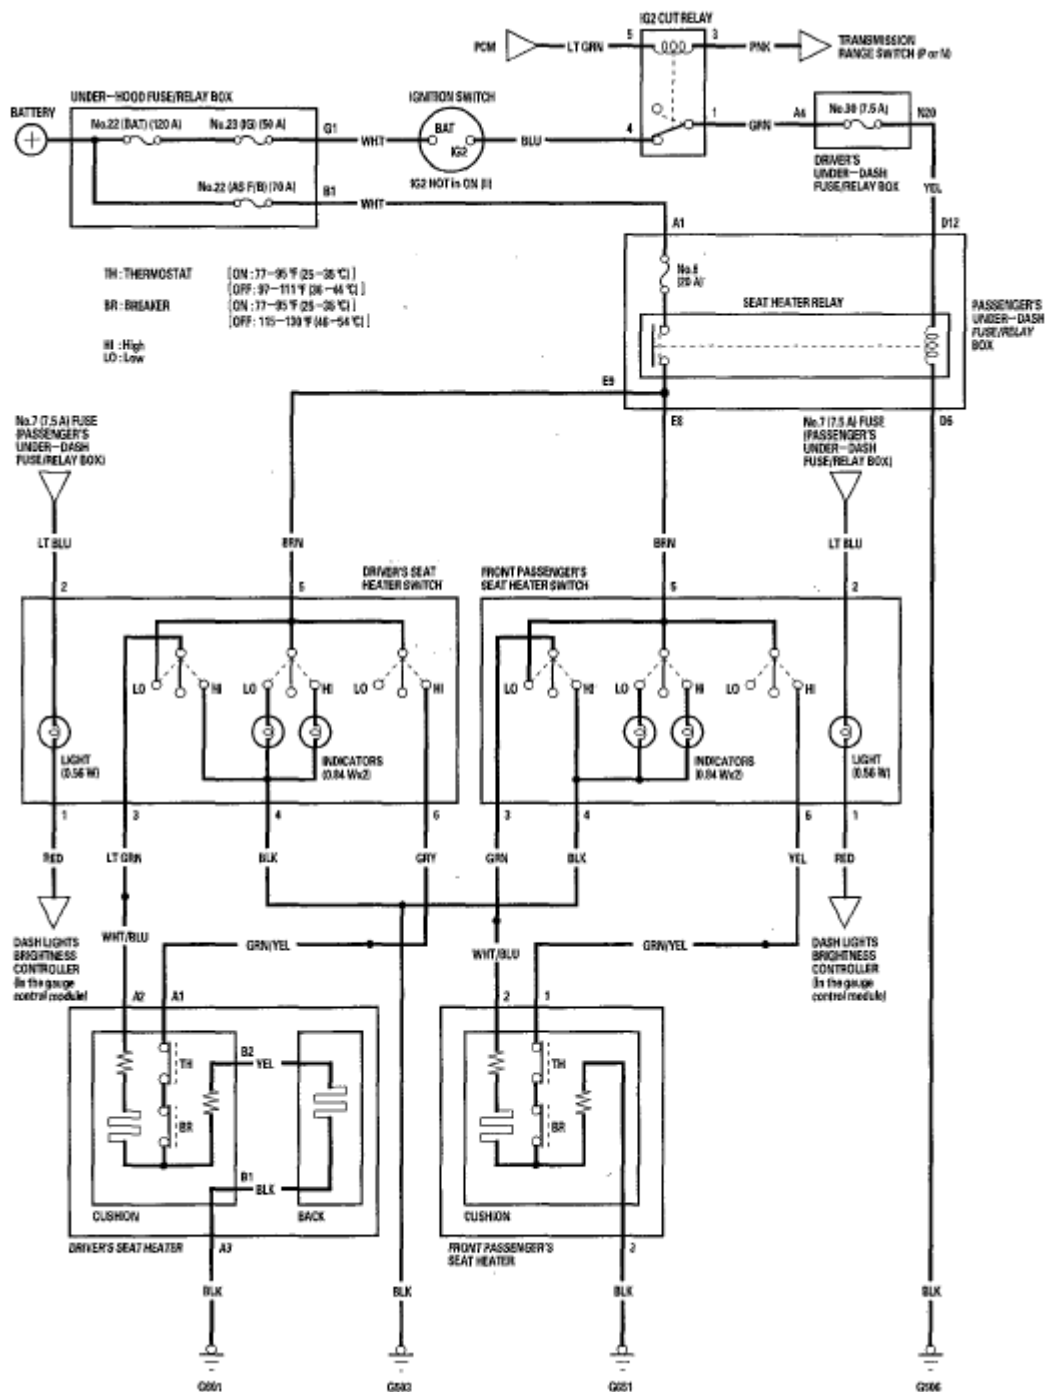
**Fig. 2: Seat Heaters - Circuit Diagram**

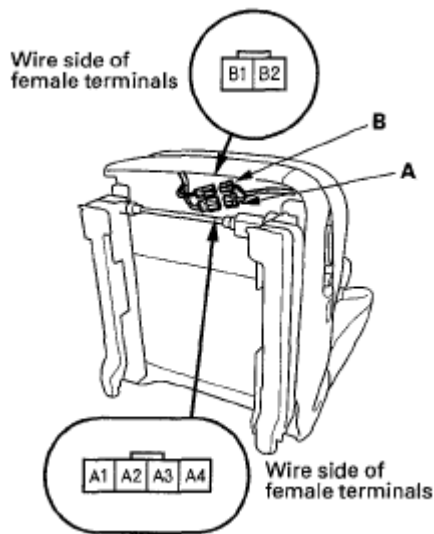
2. Disconnect the 4P connector (A) and 2P connector (B) from the seat heater.

Fig. 3: Identifying Driver's Side Seat Heater 4P And 2P Connector
Courtesy of AMERICAN HONDA MOTOR CO., INC.

3. Check for continuity between the B1 and B2 terminals of the seat-back heater 2P connector. There should be continuity.

4. Check for continuity between the A3 and B1 terminals, the A1 and B2 terminals, and the A2 and B2 terminals. There should be continuity.
5. If the continuity is not as specified, replace the appropriate seat heater.

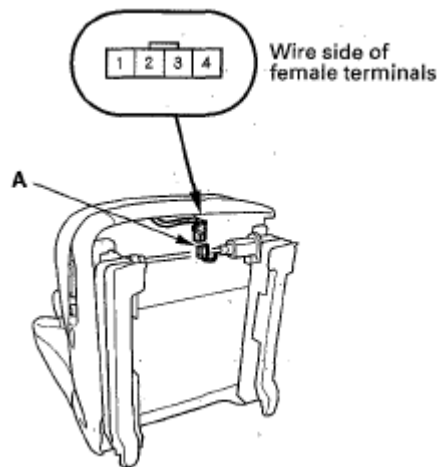
1. Remove the passenger's seat (see **FRONT SEAT REMOVAL/INSTALLATION**).
2. Disconnect the 4P connector (A) from the seat heater.

Fig. 4: Identifying Front Passenger's Seat Heater And 4P Connector
 Courtesy of AMERICAN HONDA MOTOR CO., INC.

3. Check for continuity between the No. 1 and No. 2 terminals, and No. 1 and No. 3 terminals of the 4P connector. There should be continuity.
4. If the continuity is not as specified, replace the seat heater.

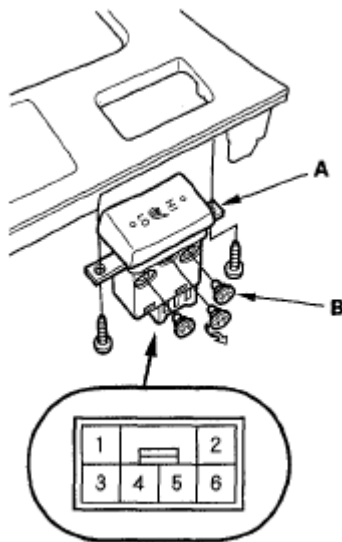
1. Remove the center console panel (see **CENTER CONSOLE REMOVAL/INSTALLATION**).
2. Disconnect the 6P connector from the seat heater switch (A).

Fig. 5: Identifying Seat Heater Switch And 6P Connector
 Courtesy of AMERICAN HONDA MOTOR CO., INC.

3. Remove the two screws and the switch.
4. Check for continuity between the terminals in each switch position (see **Fig. 6**).

5. If the continuity is not as specified, replace the illumination bulbs (B) or the switch.
